Avon Grove School District District-wide Facility Study

March 2015

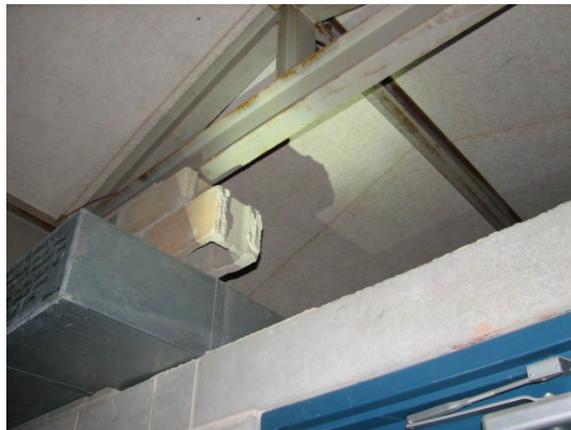
- Equipment is being stored at the top landing of stairways as well as some outdoor equipment at the bottom of stairways. Stairways are not to be used for any storage.
- The walls of the stairways are to be 1 hour rated and should extend to the roof deck or have rated ceilings. Per existing conditions, there are large openings in the walls above the ceilings at the stairways that should be filled in and rated.

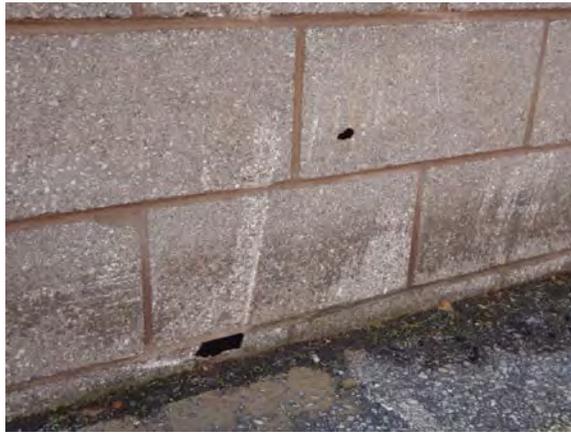
- Service area screen wall has efflorescence. It should be evaluated for water penetration into the wall that is leeching the salts from the mortar.
- Precast window sills are missing mortar which should be replaced.
- Brickwork repaired at stairway is showing signs of additional cracking.
- There are cracks in ground face concrete masonry units in the service area. Water may not be draining properly from the cavity of the wall.
- There is moisture damage to the ground face concrete masonry units in the service area. This appears to be signs of moisture not draining properly from the wall.

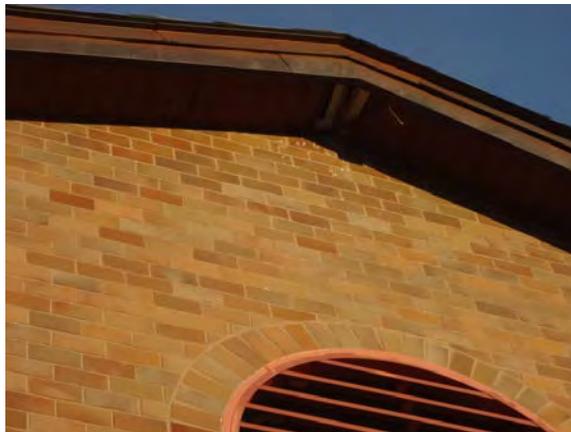
- Metal fascia above arched louver is rusting and should be painted or replaced.

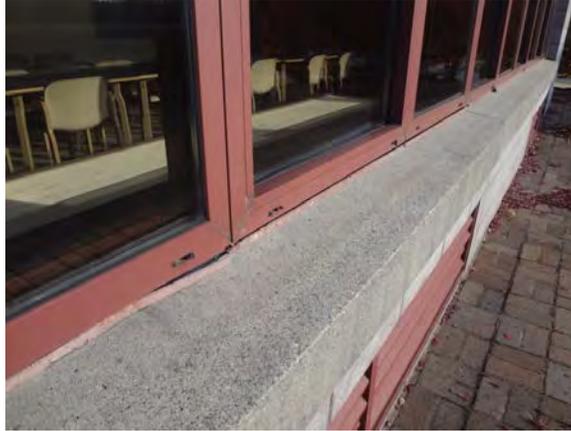
- Window lintels are peeling and should be repainted.
- Windows are aluminum with insulated glazing and are in good condition.
- Sealants around windows, particularly the bottoms are failing and should be replaced.

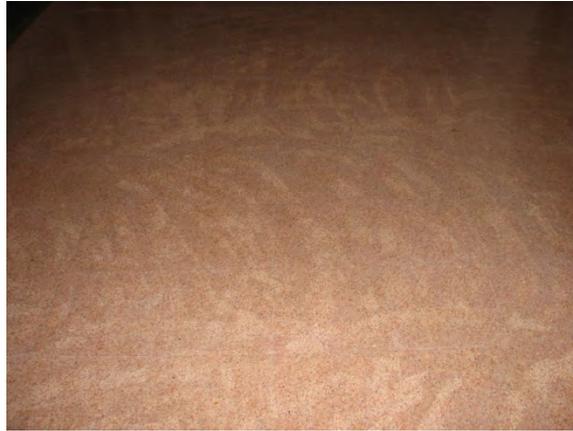
- The lobby has Fritz tile flooring, which shows signs of wear on the finish of the tile resulting in an inconsistent coloring of the tile. Walls are CMU, which are in good condition.

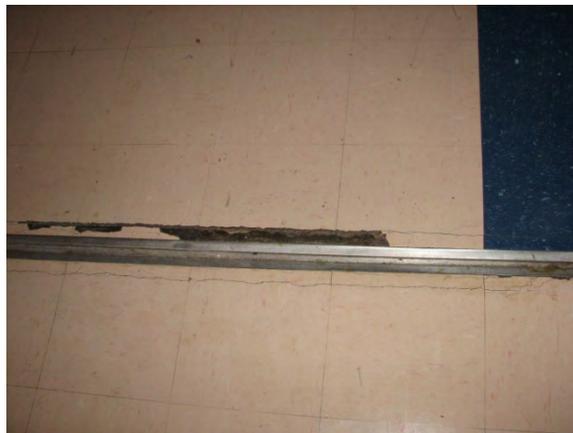
- VCT along expansion joint covers is cracking and failing. Cover plates and VCT should be replaced.

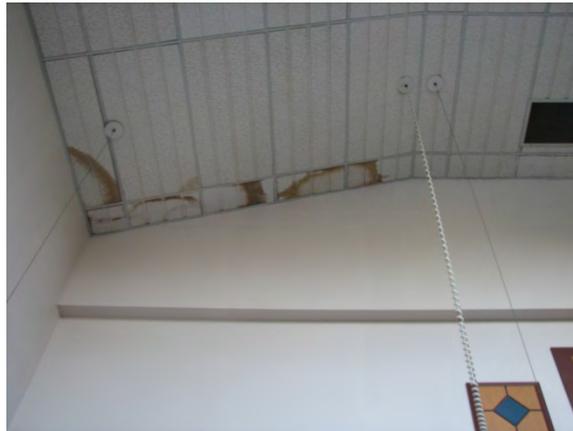
- Acoustical tile ceilings are in good condition, except some are water damaged in areas where previous roof leaks occurred.

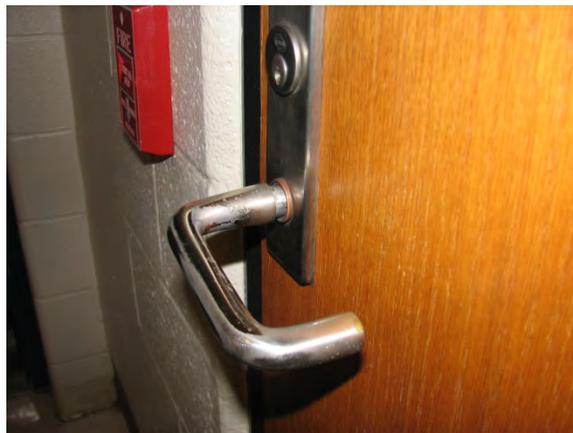
- “Total door” hardware is showing signs of age and wear and will need to be replaced as it fails. “Total doors” have plastic parts that will ultimately break down over time.

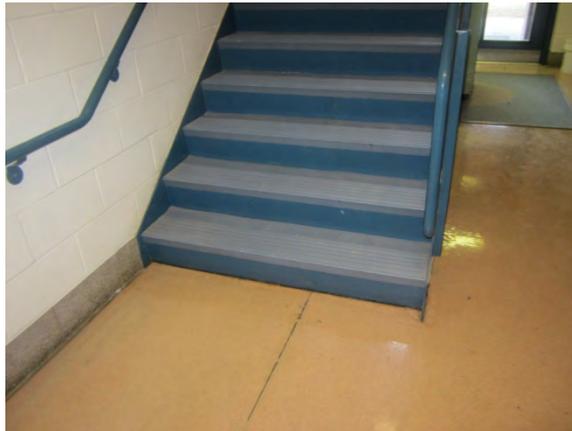
- Exposed ductwork has some peeling paint that needs to be replaced in storage rooms.
- Vinyl flooring at stairs is separating at the seams and should be replaced.

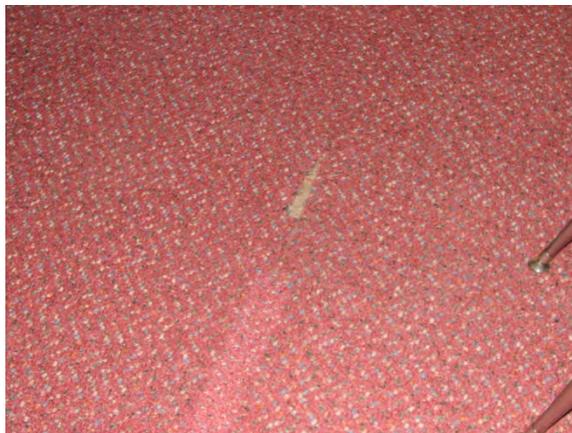
- Classroom carpeting is worn and seams are failing. Carpeting should be replaced in all classrooms.

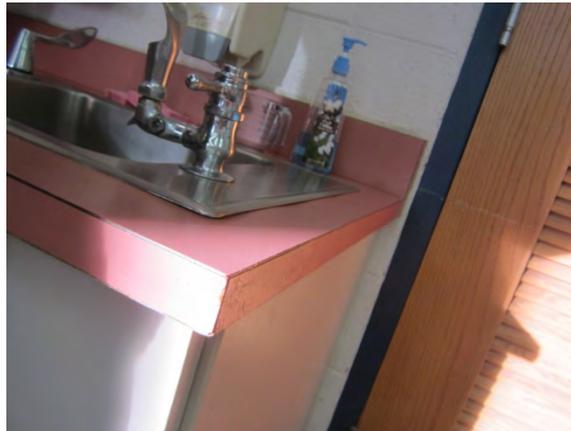
- Plastic laminate countertops have absorbed water around sinks where sealant has failed. Sink countertops should be replaced with a water resistive material such as solid surfacing.

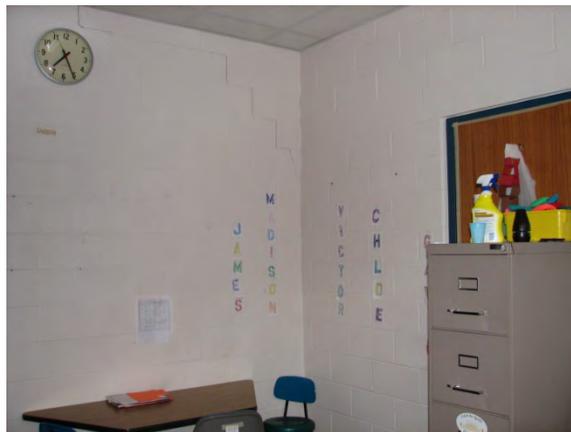
- Carpeting in the Large Group Instruction is worn and should be replaced.
- Blinds at high windows in LGI are manually controlled. Due to the height of the windows, consideration should be given to providing motorized blinds.
- There are some minor wall cracks in OT support room. Patch walls and repaint.

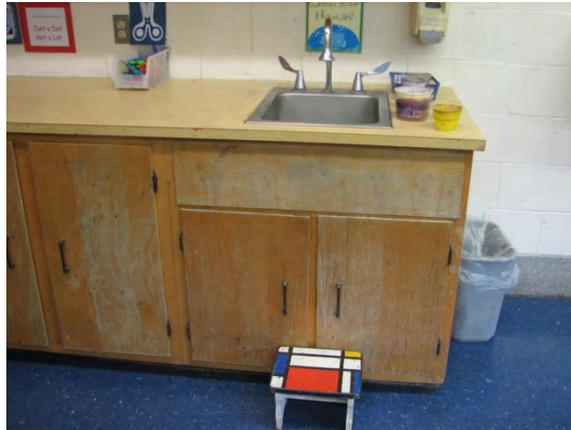
- Wood casework in Art Classroom is water damaged and the veneer is peeling. Plastic laminate countertop has absorbed water and is in poor condition. Casework in art classroom should be replaced. Solid surface or other water impervious materials should be considered for wet areas. Art Room VCT and walls are in good condition.

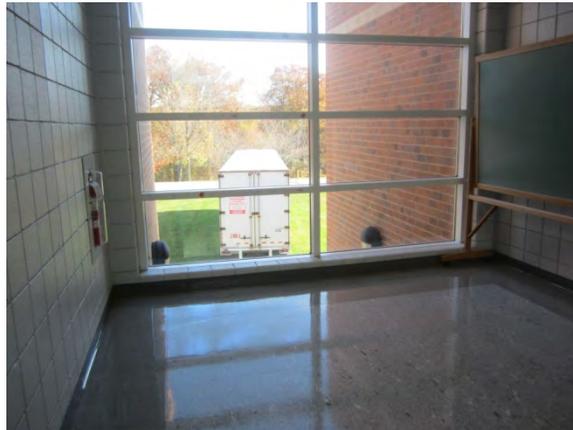
- There are large full-height fixed window openings in the main floor corridor that have no protective rails in front to prevent someone from falling through the glazing. Guardrails should be installed at these windows on the upper floor level.

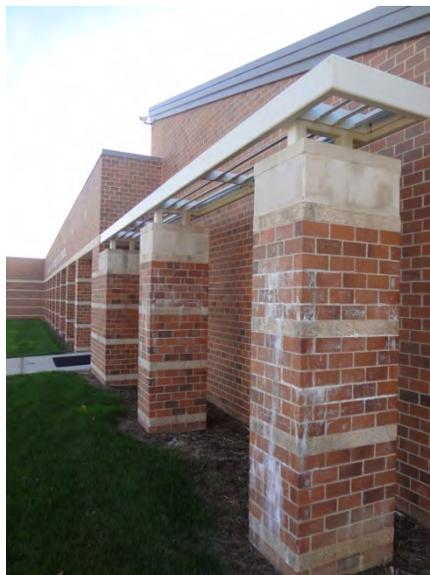
- Overall the brick masonry is in good condition. There is some minor discoloration of the brick at exterior hydrants and vents.
- Some of the columns show signs of efflorescence and should be cleaned. If efflorescence continues, the columns should be checked for water infiltration.

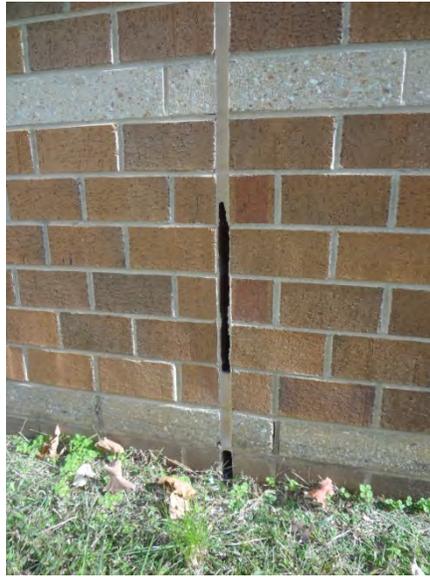
- Some of the control joint sealants are failing and should be replaced.

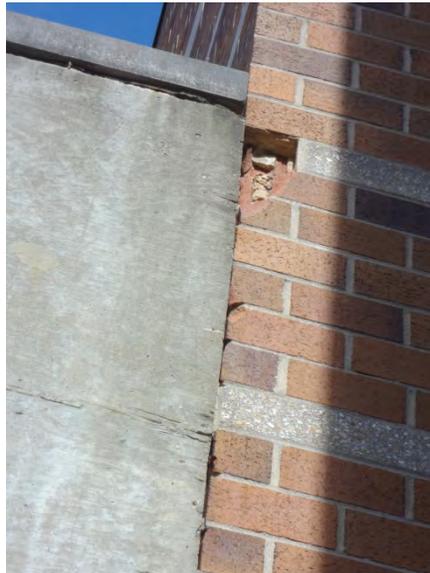
- There is some small brick and limestone damage by the concrete retaining wall. The brick is broken to the cores of the brick and should be replaced before water penetration becomes an issue.

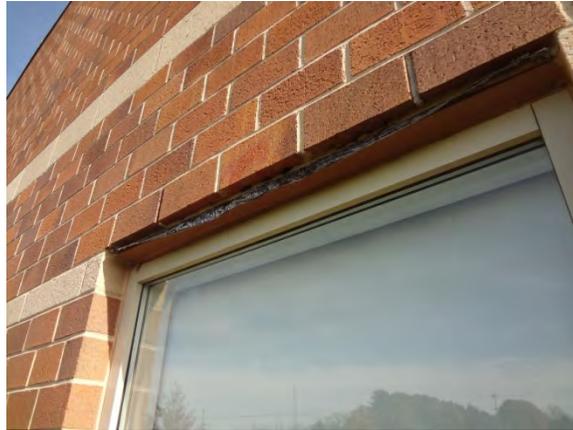
- The windows are insulated aluminum windows with fixed and operable window panels that are in good shape. Some windows have flashing that overhang the windows at the head of the window. The flashing should be flush with the frame.

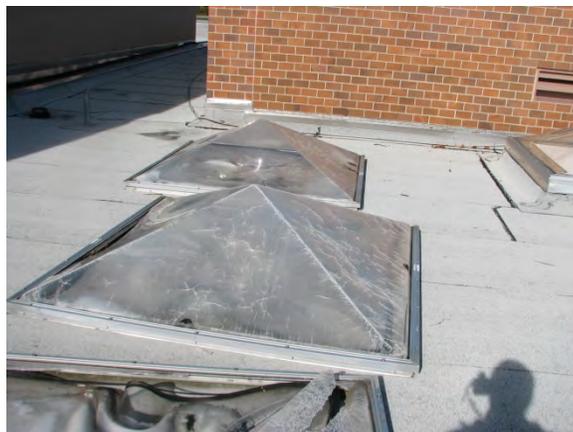
- Modified bituminous roofs have been installed across the building and are in good condition. The roof drains had not been installed correctly and have been an ongoing issue. At the time of inspection, these drains were being repaired and this issue should have been corrected.
- The original skylights had issues with leaking around the perimeter and have been replaced. The skylight debris was left on the roof and should be removed and cleaned up.

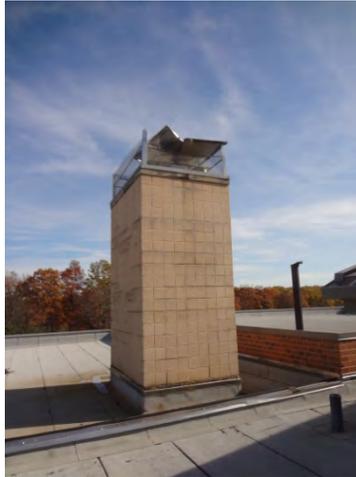
- The masonry of the chimney is in good condition, however it is absorbing water and should have water repellent reapplied. Additionally, the screened cap has been damaged and should be replaced.

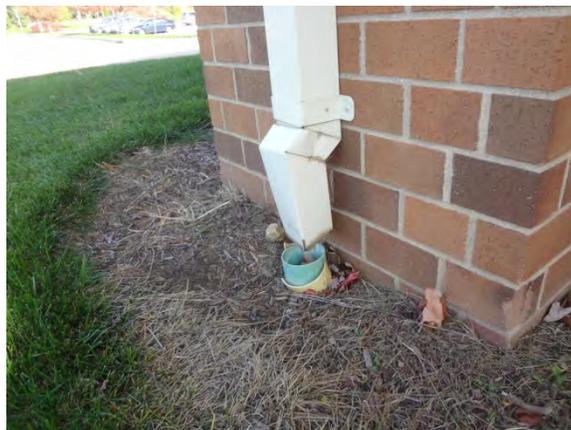
- There are downspouts that do not connect completely to downspout pipes. This should be repaired before erosion begins to occur.

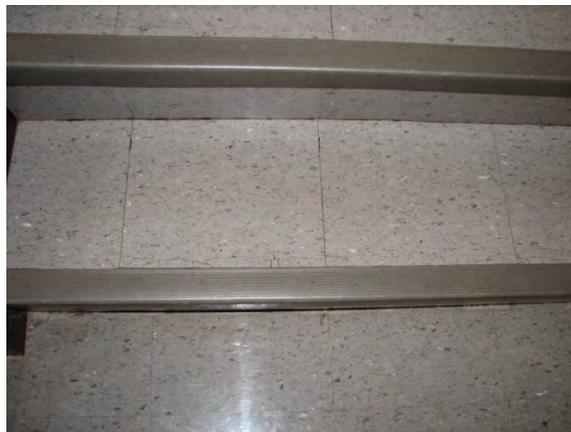
- The two internal monumental stairs between the main and lower levels have enhanced VCT that is cracking and damaged at the joint with the rubber nosings. Replacement with full rubber treads should be considered.

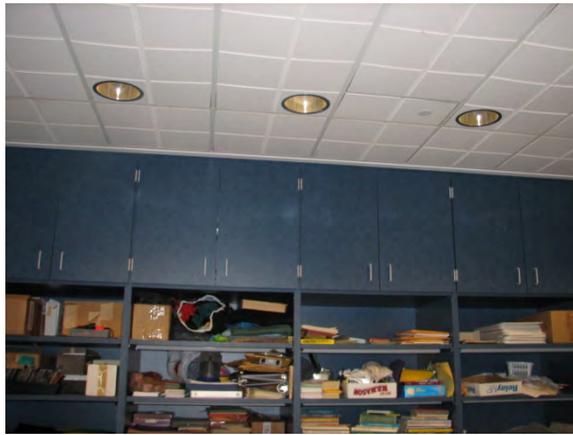
- The perimeter ceiling tiles in the music classroom shows signs of bowing due to airborne moisture and should be replaced.

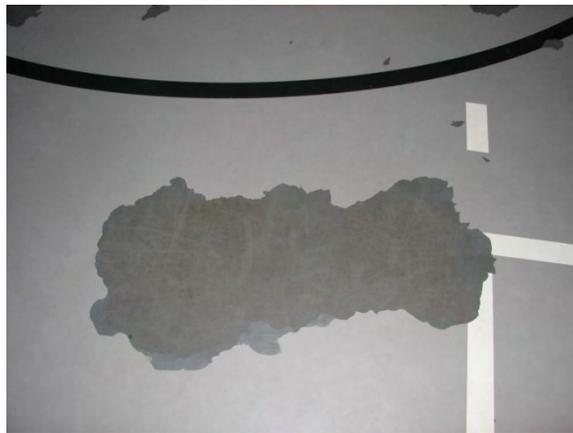
- The sport floor in the gymnasium is in poor condition as the surface has separated from the substrate. The floor replacement has been budgeted as part of the School District's 5-year plan.

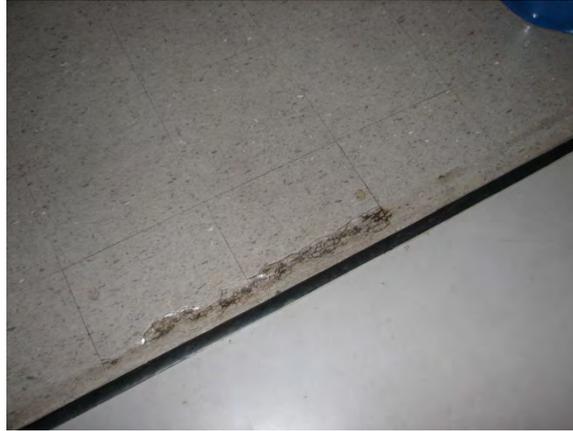
- Cracks have formed in the floor and some low concrete masonry units along the wall of the gymnasium where the building transitions from slab on grade to steel-framed upper floor due to differential movement of materials. These cracks appear to be minimal and mostly cosmetic, but may require additional monitoring if they grow larger. Most cracks are not in the path of travel but should be repaired to prevent a tripping hazard.

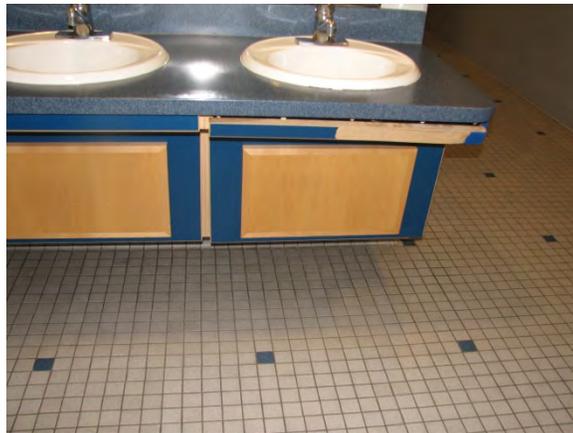
- Plastic Laminate trim at the sinks in the boy's bathroom has been damaged and should be repaired. Other finishes are in good condition.

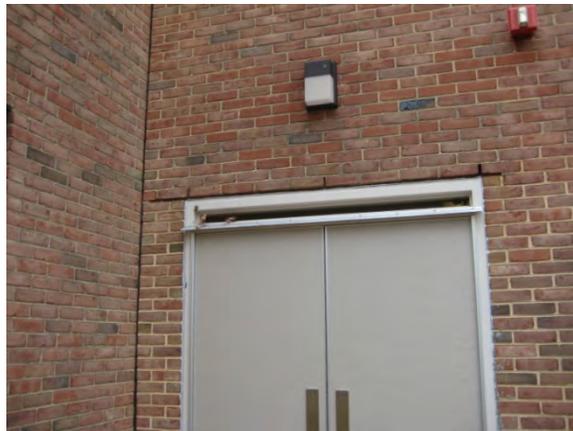
- Some exterior door lintels show signs of rust. These lintels should be sanded, prepped and repainted.

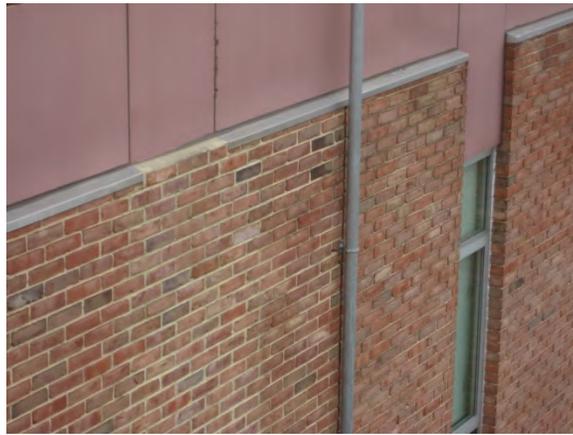
- There are small cracks in the mortar joints near the main entrance. These joints should be cleaned and repaired.

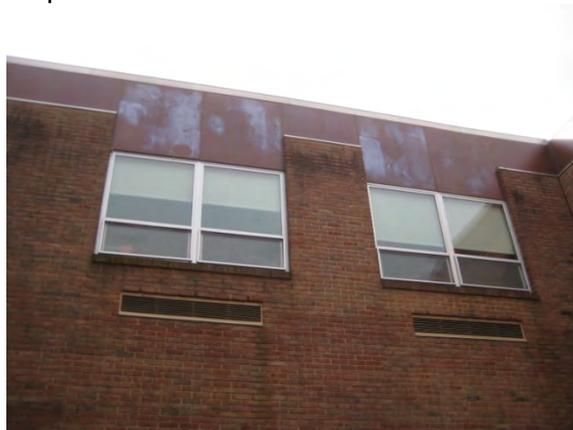
- The metal panels at the top of the walls are generally in good condition, however there are a couple panels where the finish is compromised and showing signs of degradation. These panels should be refinished or replaced.

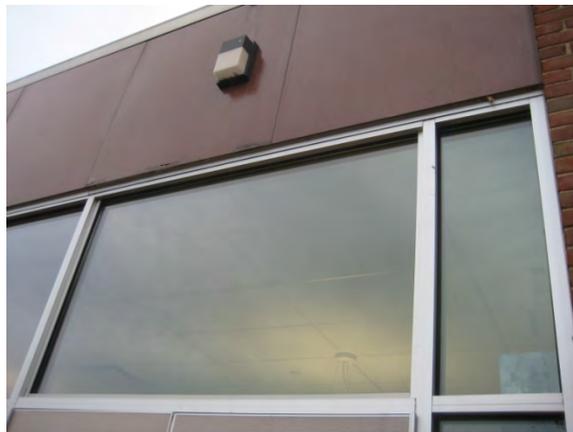
- There are also several panels by the main entrance by the picnic tables that have rusted penetrations at the bottom of the panels. These panels should be replaced.

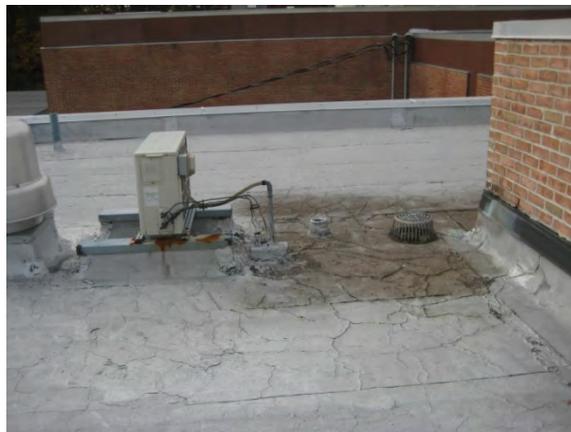
- The toilet room addition has aluminized coated EPDM roofing where the coating is alligatoring due to heat and aging. The roofing should be cored and evaluated if it needs to be replaced or recoated. The elevator shaft has EPDM roofing that appears to be in good condition.

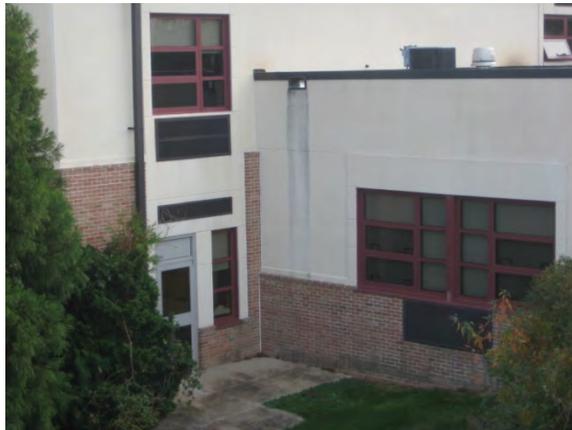
- There are some areas where the EIFS has been stained by water at scuppers.

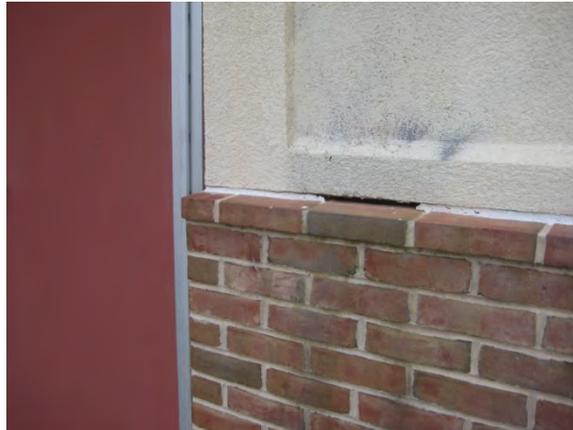
- There is significant dirt build-up on the brick that should be cleaned and sealed. There are some minor cracks and damaged brick that should be repaired.

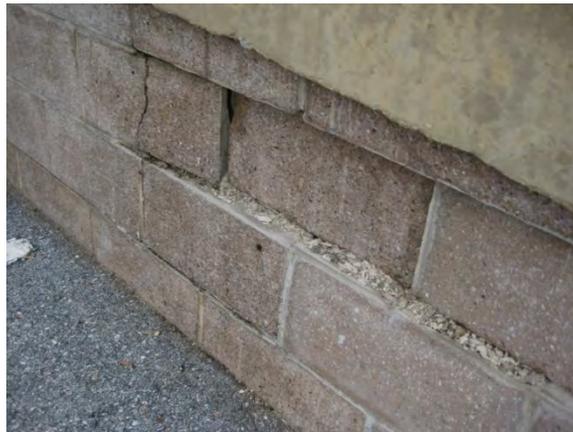
- There is damaged CMU along the ramp, to access the loading dock, from a vehicle impacting the wall.

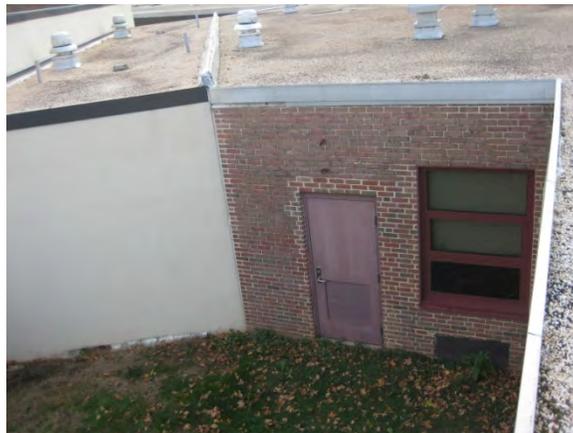
- The existing ballasted built-up roof is overall in good condition. As the roof is aging it is recommended that it be re-coated to extend the life of the built-up roofing. Existing standing seam roofing is located over the classroom wing and Media Center that is in good condition and has appropriate snow guards to prevent ice damage.
- Gutters have been damaged and worn and should be replaced. Flashing repairs will be necessary with that work.

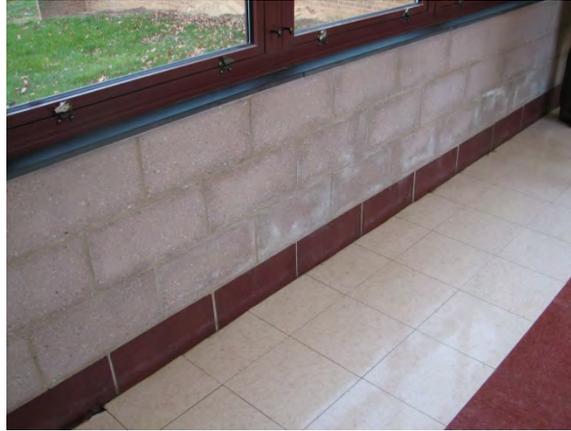
- Acoustical tile ceilings are in good condition, except some are water damaged in areas where previous roof leaks occurred.
- Walls are in good condition but painting is recommended to freshen up the appearance of the building and maintain the clean ability of the walls.
- There are ground-faced CMU walls at the ramped hallway without handrails that show signs of water infiltrating the wall.

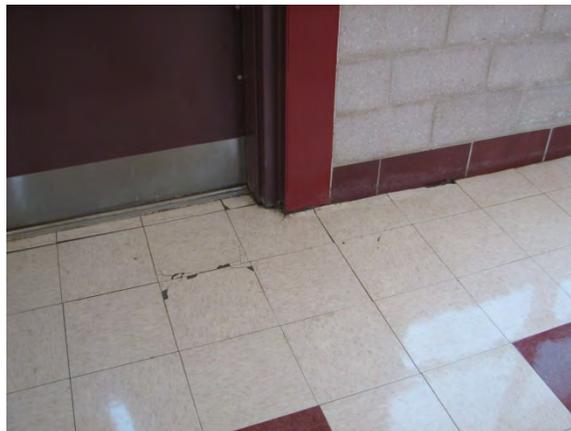
- There are some damaged VCT tiles in the hallway that should be replaced.

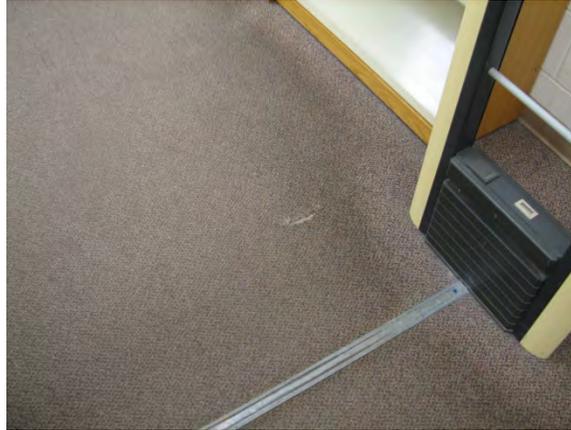
- Hallway lockers are showing signs of heavy use and will require repairs and should be repainted or replaced.
- The administration area and guidance carpets are worn and should be replaced.

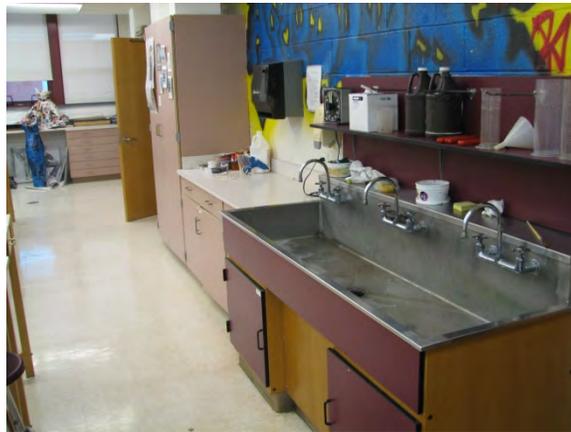
- Art and Technology Education rooms do not have front approach ADA sinks.

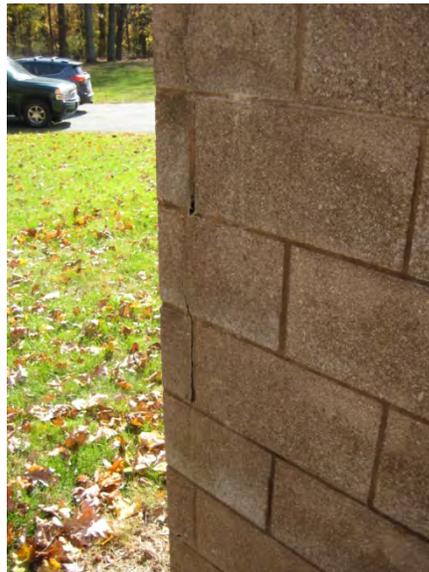
- The control joints in the ground-face concrete masonry units do not appear to be spaced closely enough at the building corners as there are cracks that have formed to relieve the thermal pressures. Control joints should be cut into the masonry to relieve the stresses.
