Avon Grove School District District-wide Facility Study

March 2015

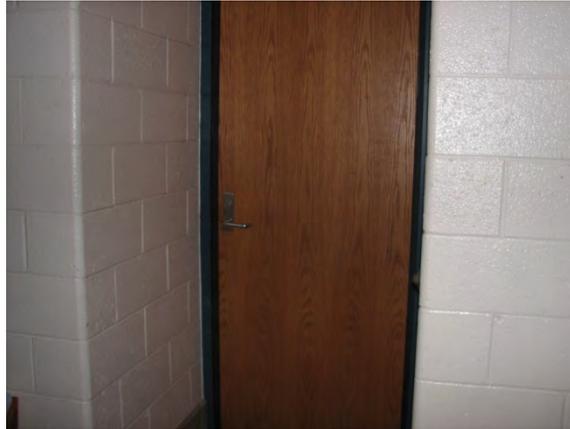
- Door approach and wall clearances at a number of support entrances do not comply with ADA requirements. The door and wall configurations will need to be revised. (OT, Reading, and other spaces).

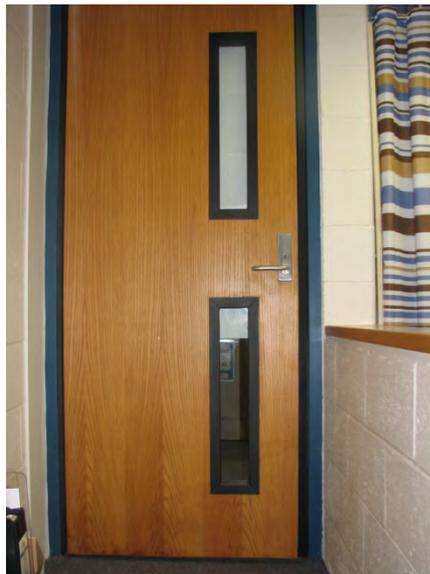
- The hallway ramps are 32' in length, which exceed the allowable length for a ramp of 30' without a landing. Handrails do not extend 1' beyond the length of the ramp on both ends.
- Several doors to library support rooms do not have the required ADA clearances on the latch side of doors. Doors with glazing in this area have vision panels that are too high per code requirements. Vision panels are required to be no higher than 43" above the floor for ADA requirements.

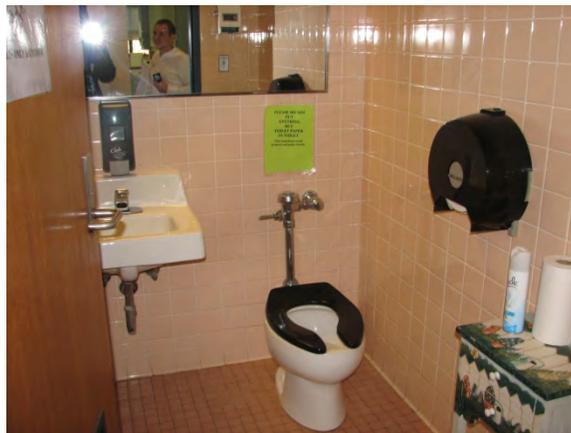
- Toilet rooms in the administration and nurse's area are not ADA compliant. Toilet rooms in 1992 building classrooms also are not ADA compliant. The fixtures do not have the required clearances, no grab bars are present, and mirrors are installed too high. Kindergarten center toilets are ADA compliant.

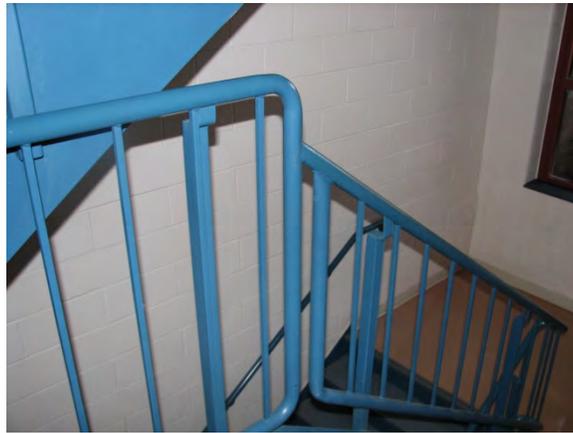
- Stairway balusters are to be spaced no more than 4" apart per current code requirements. Railings should be modified to meet current code requirements.
- Steel beams are exposed in stairs and should have 1-hour fire rating per building code. Layers of gypsum wallboard, CMU wall infill, or Intumescent paint can achieve this.
- Guardrails are not high enough along the open side of the stairs per current codes.

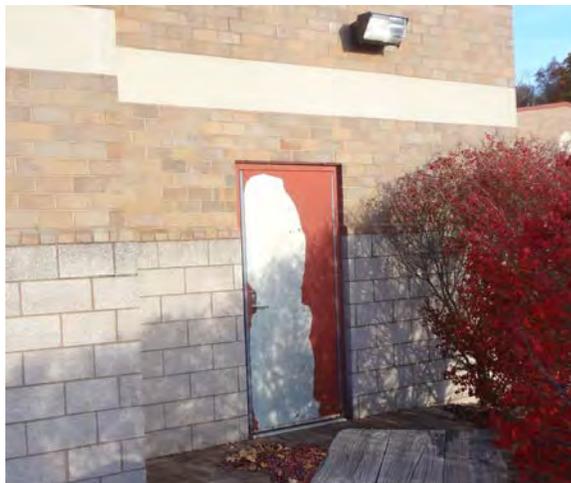
- Exterior doors are hollow metal and many of them are peeling and should be repainted.

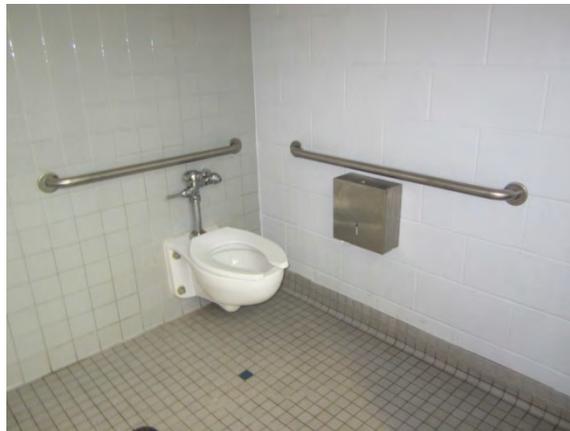
- ADA toilet stalls do not have the 18" vertical grab bar to assist with sitting and standing in the stall. Fixtures, clearances and accessories are ADA compliant.

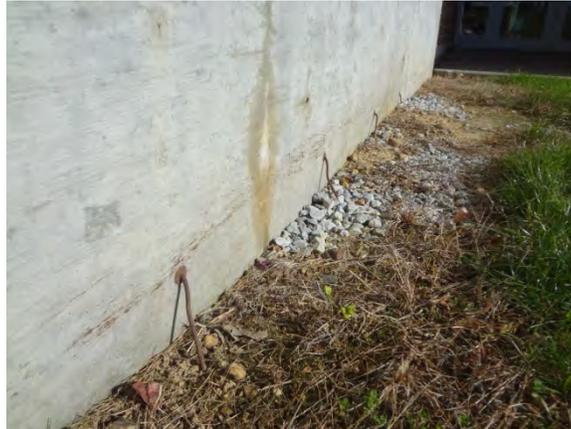
- The concrete retaining wall has steel ties that extend beyond the face of the wall and are a safety concern. They should be cut back flush to the wall.

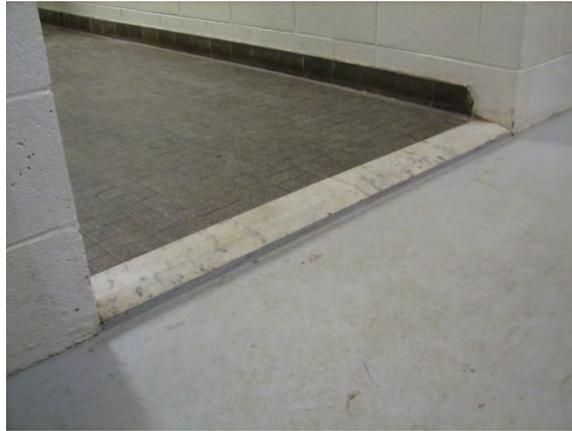
- Marble thresholds at shower entrances are too high per current ADA codes. Floors should be flash patched to reduce threshold heights to fall within the allowable 1/4" height.

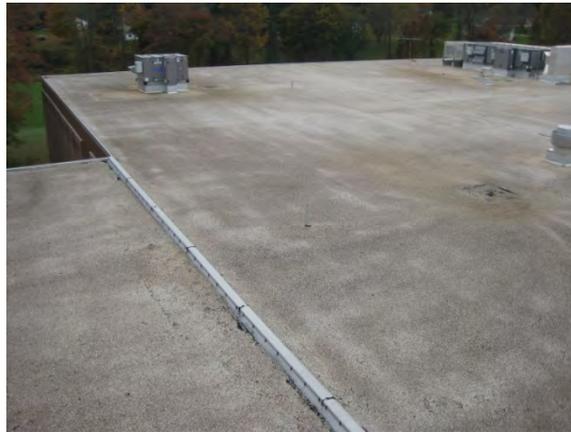
- There are rooftop HVAC units that are within 10'-0" of the roof edge that do not have safety rails to protect maintenance workers around the units. Guardrails should be installed to provide the additional safety to meet code.

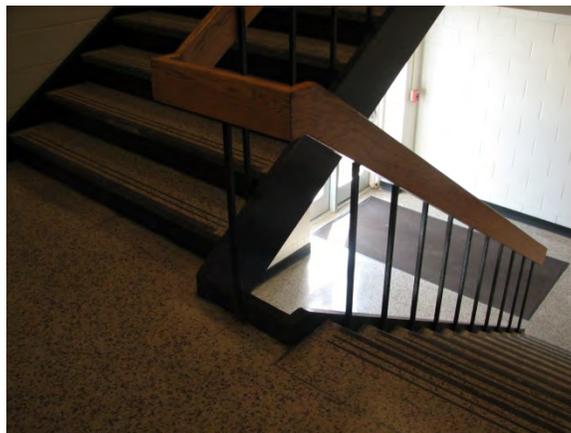
- The entrance to the connected modular classrooms is through one existing stair tower. The hallway runs under the existing stair landing which does not meet the required minimum height by code.
- The existing stair guardrails are not high enough to meet current codes and the spacing between pickets exceeds the maximum of 4" as required by current codes.

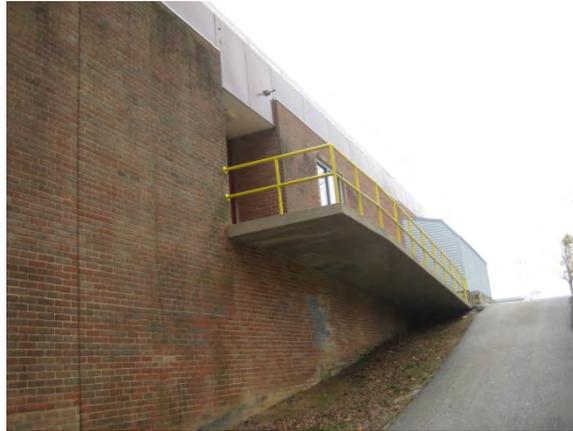
- The exterior walls are brick veneer that is in good condition. Some of the control joints on the building, particularly on upper wall areas have failing sealant that should be replaced. It is recommended that the brick be cleaned to remove dirt and waterproofed, as there are signs that the brick has been holding moisture.

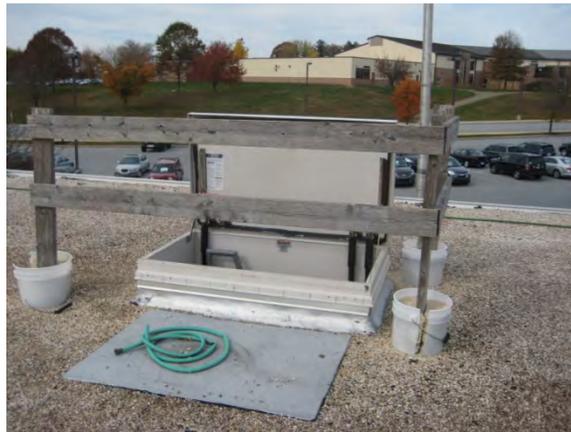
- Most of the roof is ballasted built-up roofing that is in good condition. The existing roof hatch does not have any safety provisions. Safety rails should be installed along with rails along the parapet for fall prevention.

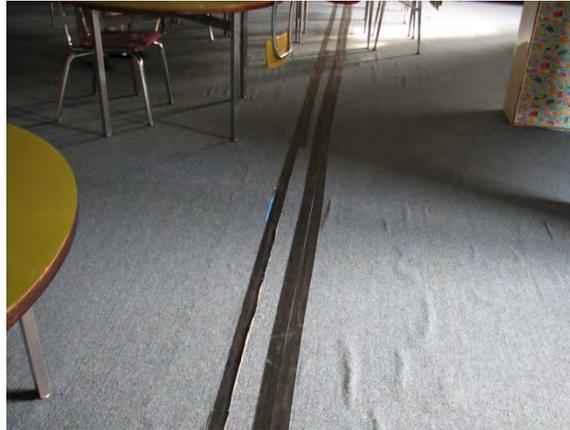
- Some classrooms are modular classrooms. Five rooms have been in place for a significant time and have issues with moisture and dampness. Carpet in these modular classrooms is in very poor condition with seams taped together. Another building of four classrooms and office support areas is more recent and in fair condition. It is recommended that all modular classrooms be removed or replaced with permanent classrooms to improve security and the teaching environment.

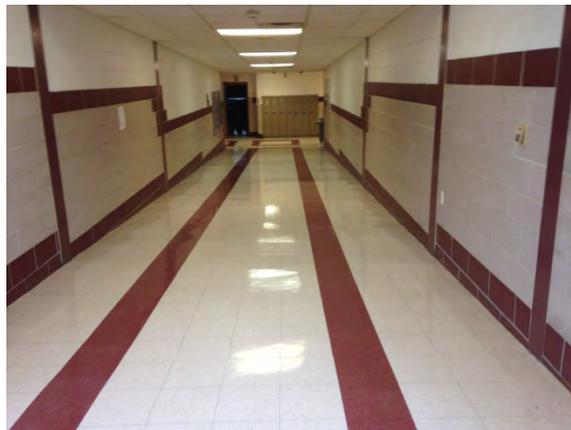
- There is a hallway ramp with no handrails as required by ADA. Handrails should be provided in the ramped corridor.

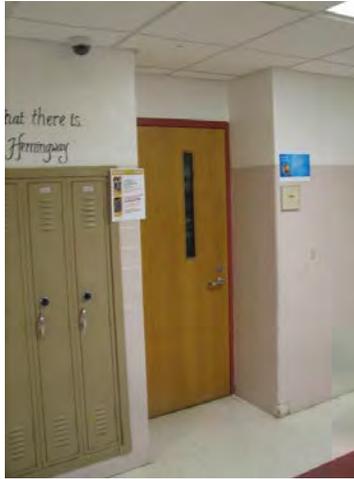
- Door approach and wall clearances at many of the classroom entrances do not comply with ADA requirements. The door and wall configurations should be revised if renovations are being considered.

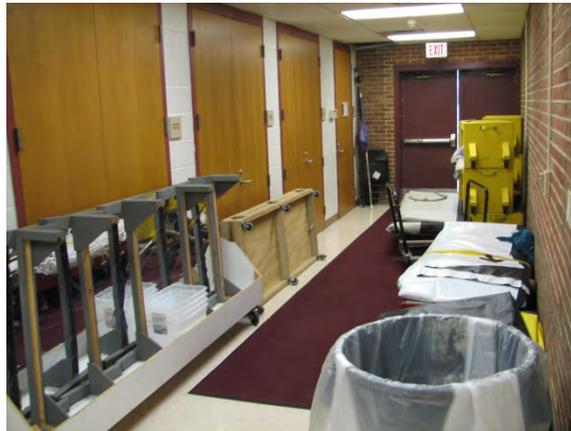
- Materials are being stored in the hallways, as there are not adequate storage rooms in the building.

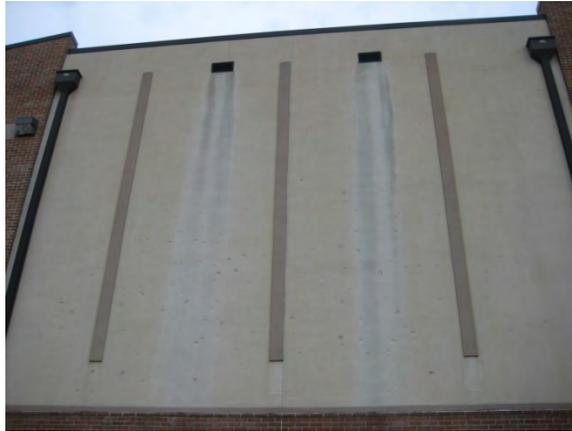
- The exterior is brick veneer base with EIFS finish above. The brick veneer is in good condition. The EIFS generally is in good condition. Some edges of the EIFS have developed cracks that have been sealed.
- The EIFS at the auditorium has been dented by balls and should be repaired.

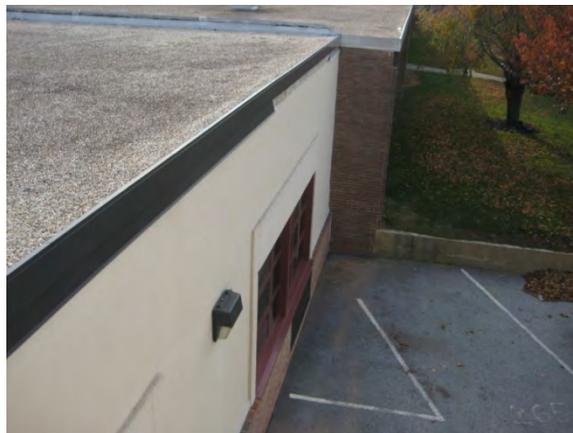
- Some sections of metal coping are missing from the building and should be repaired to prevent moisture from getting in the wall cavity.

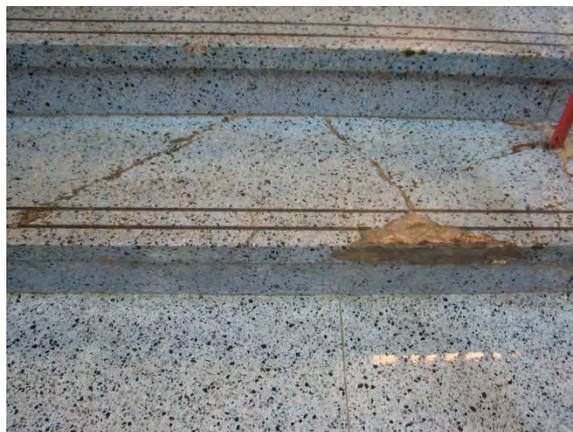
- The lobby has terrazzo flooring which is generally in good condition. The steps in the lobby have cracks and the terrazzo should be repaired. The CMU walls are in good condition.

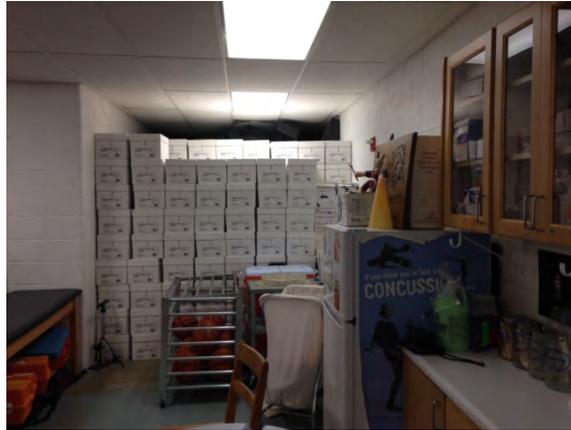
- A corner of the Trainer's room is used for paper storage. There is a very large quantity of copy paper boxes. As this area is located above the lower level, floor structure should be evaluated to confirm that the floor is not overloaded.

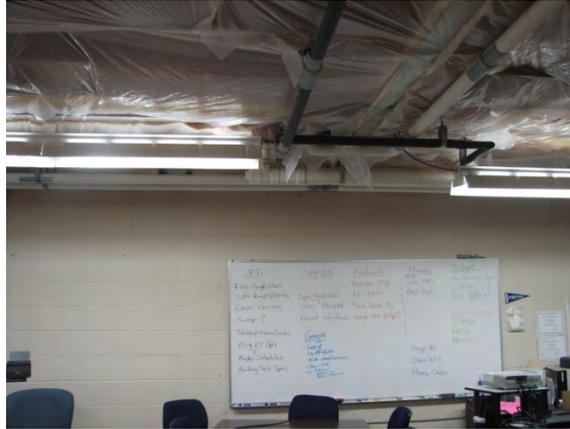
- The building houses administration staff for the district with the exception of the Supervisor of Special Education, the Director of Elementary Education and the Director of Secondary Education, who are satellited to other buildings in the district. The building is undersized to accommodate the entire district administration.
- The lower level of the building serves as a storage area, with areas converted to office space and a technology work area. Plastic has been attached to the underside of joists over the technology work area.

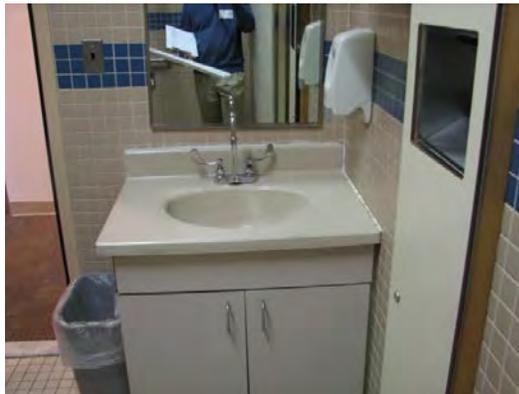
- The toilet room entrances and fixtures do not comply with ADA requirements. Fixtures do not have the clearances to be considered compliant with accessibility requirements. The sink is not compliant as the sink is a lay-in sink in a base cabinet and does not allow for wheelchair access.

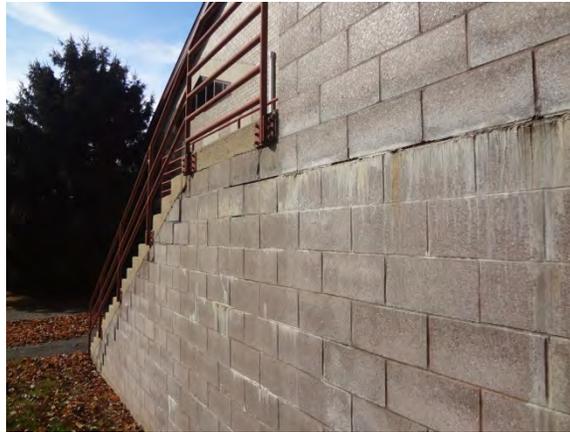
- Existing exterior of the building is brick above a precast water table and ground face. The brick veneer and mortar are in good condition. The ground-face concrete masonry units (CMU) are in good condition on all sides of the building except the rear walls by the stairs. There are significant cracks and efflorescence in the walls under and behind the stairs. It appears that moisture is getting in the wall and leaching out masonry and mortar salts. There are also minor areas of spalling CMU at the concrete slab at the top of the stair.

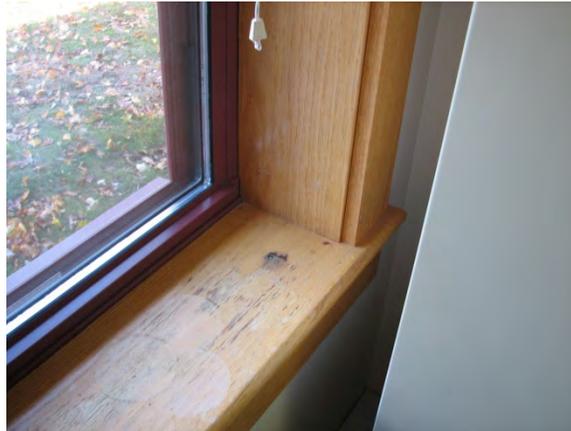
- Numerous wood windowsills in the building show signs of water damage. These sills should be repaired and refinished.
